Abandoned Uranium Mine Site Assessment for the Eugenie Site (NM0130)

FINAL REPORT

NM0130

April 14, 2010

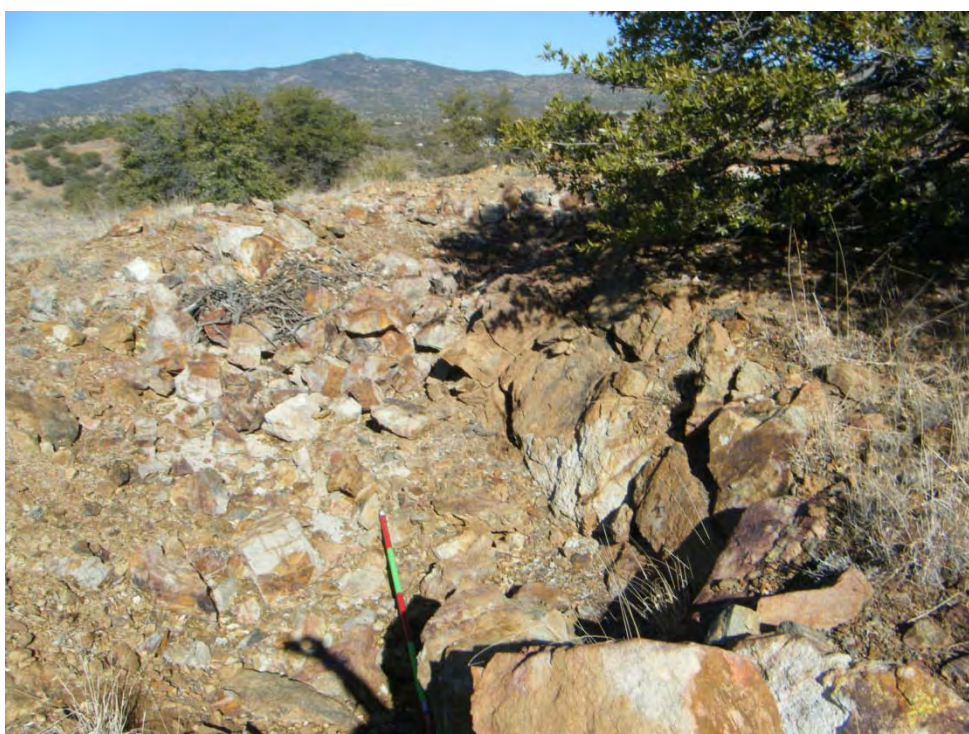
| Feature Name | On Site? | Feature Type | Associated Feature | Material | Height or Depth (ft) | Width or Diameter (ft) | Length (ft) | Open | Collapsed | Closure Type | Associated Photo | Notes |
|---|---|---|---|---|---|---|---|---|---|---|---|---|
| Pit-1 | Yes | Exploration | -- | -- | 4 | 8 | 15 | Yes | No | -- | NM0130_002 | -- |

Photo 2-Looking west at Pit-1.

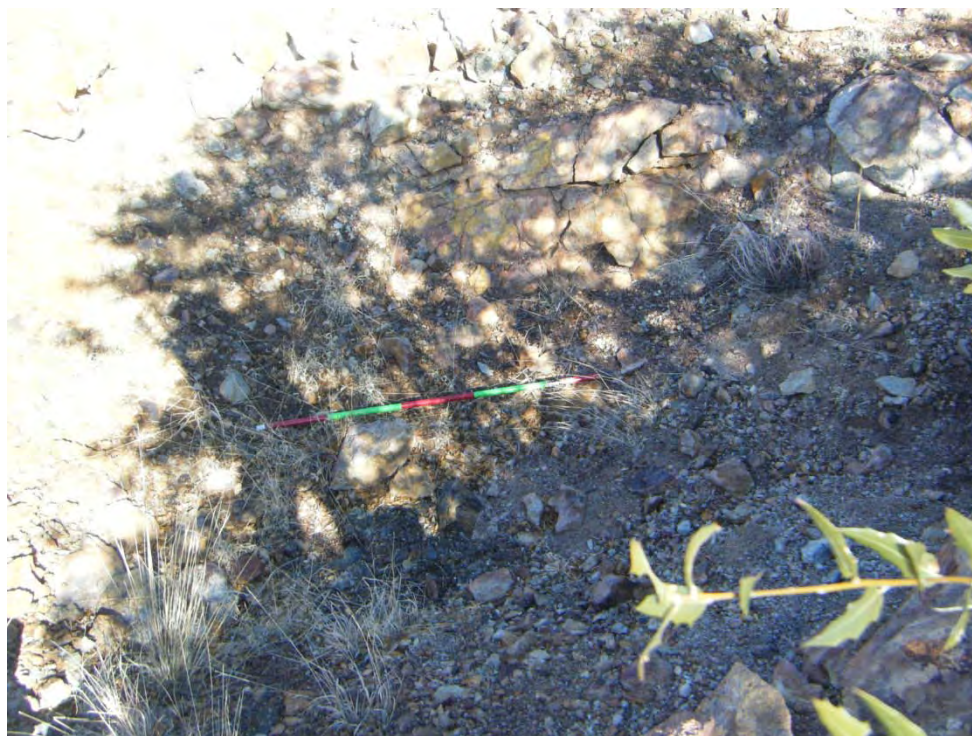
| Feature Name | On Site? | Feature Type | Associated Feature | Material | Height or Depth (ft) | Width or Diameter (ft) | Length (ft) | Open | Collapsed | Closure Type | Associated Photo | Notes |
|---|---|---|---|---|---|---|---|---|---|---|---|---|
| Pit-2 | Yes | Exploration | -- | -- | 6 | 25 | 25 | Yes | No | -- | NM0130_003 NM0130_004 NM0130_013 | -- |

| Reading ID | Asssociated Feature | Reading at 0ft Above Ground (μR/hr) | Reading at 4ft Above Ground (μR/hr) | Associated Photo |
|---|---|---|---|---|
| Rad-2 | Pit-2 | 45 | 39 | NM0130_003 |

Photo 3-Looking west at Pit-2.

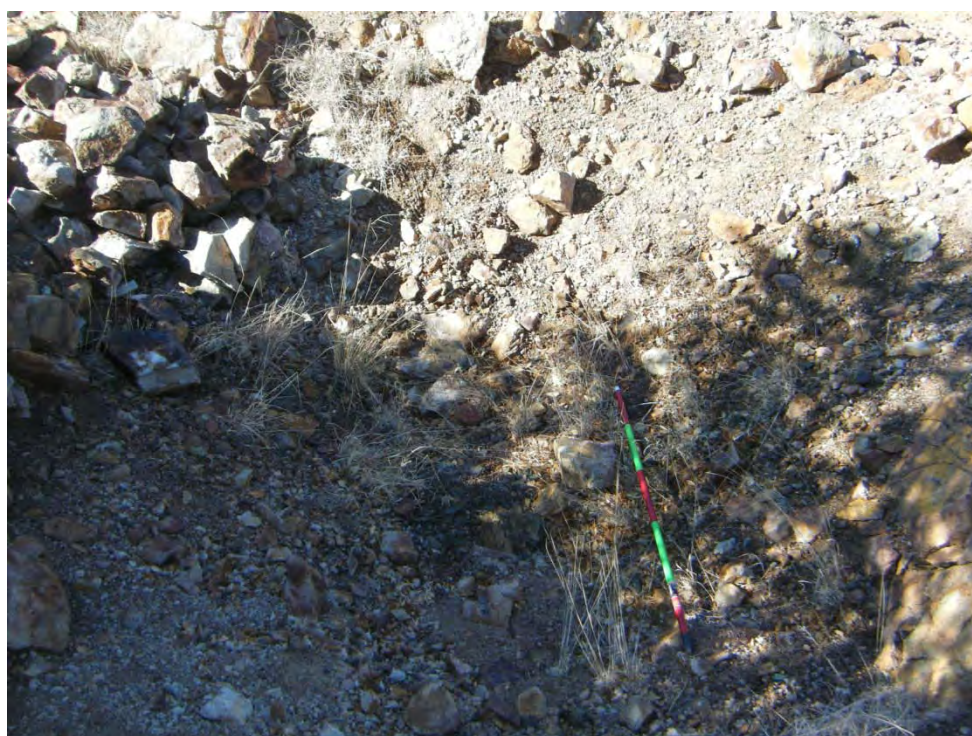
Photo 4-Looking south at Pit-2.

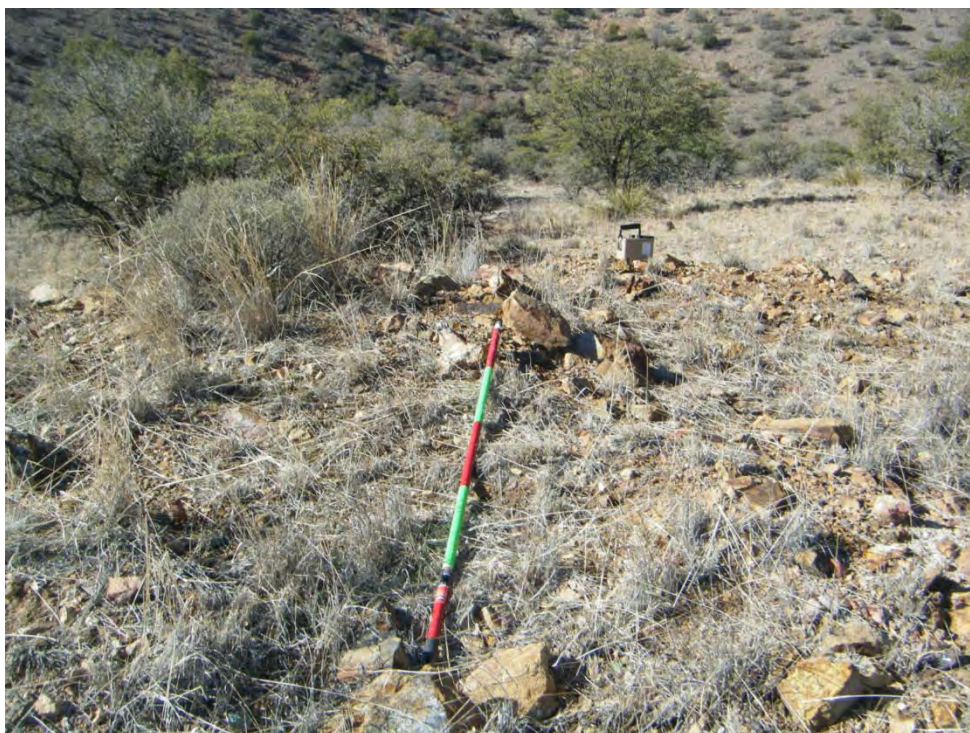
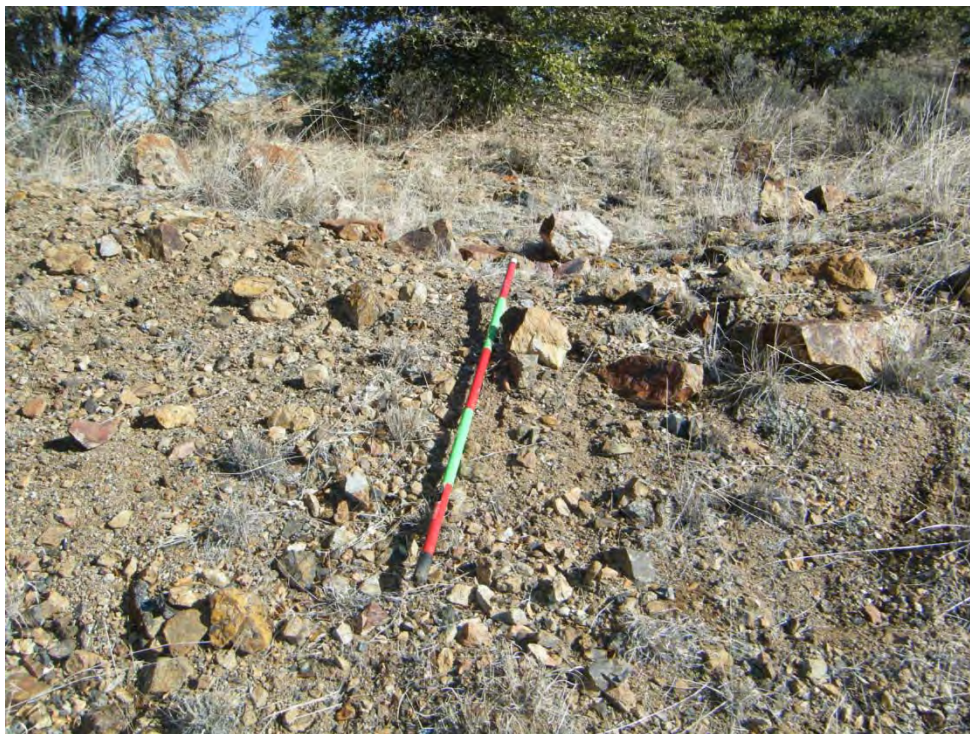
| Feature Name | On Site? | Feature Type | Associated Feature | Material | Height or Depth (ft) | Width or Diameter (ft) | Length (ft) | Open | Collapsed | Closure Type | Associated Photo | Notes |
|---|---|---|---|---|---|---|---|---|---|---|---|---|
| Pileridge-1 | Yes | Waste | DistPly-1 and Pit-1 | Rock | 3 | 15 | 35 | -- | -- | -- | NM0130_005 NM0130_006 NM0130_007 | -- |

| Reading ID | Asssociated Feature | Reading at 0ft Above Ground (μR/hr) | Reading at 4ft Above Ground (μR/hr) | Associated Photo |
|---|---|---|---|---|
| Rad-3 | Pileridge-1 | 40 | 33 | NM0130_005-007 |

Photo 5-Looking west at Pileridge-1.

Photo 6-Looking south at Pileridge-1.

Photo 7-Looking north at Pileridge-1.

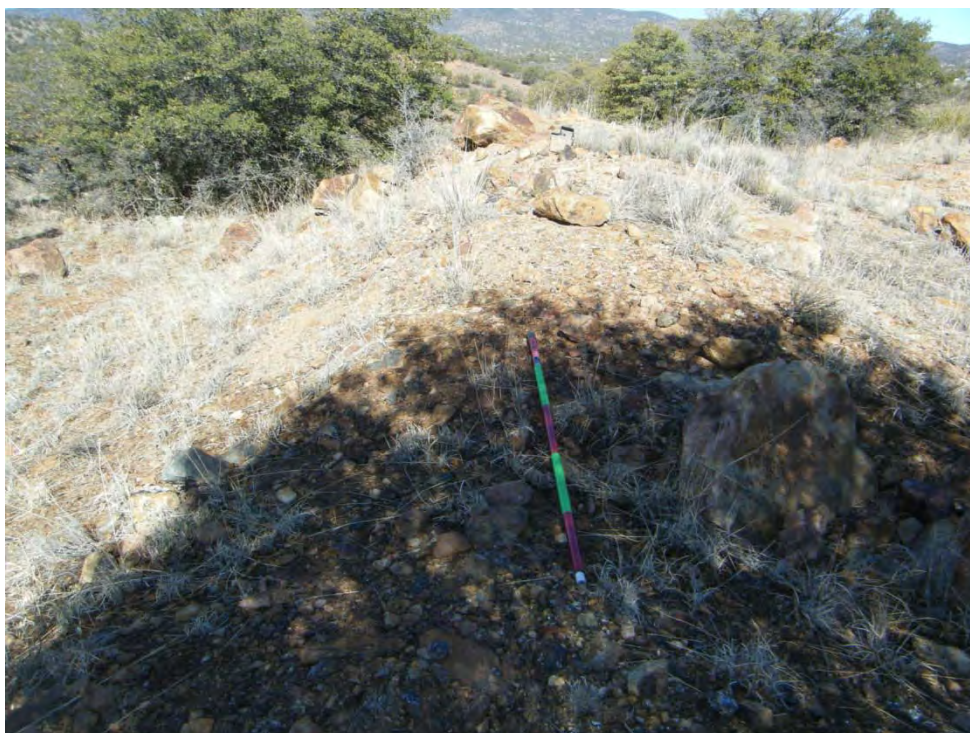
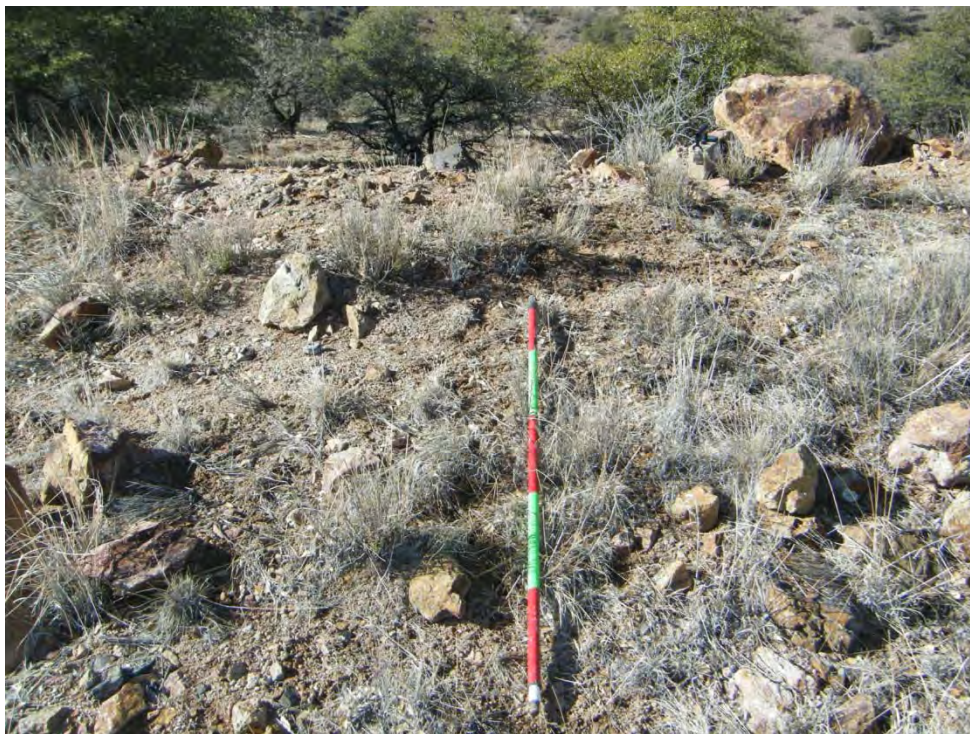
| Feature Name | On Site? | Feature Type | Associated Feature | Material | Height or Depth (ft) | Width or Diameter (ft) | Length (ft) | Open | Collapsed | Closure Type | Associated Photo | Notes |
|---|---|---|---|---|---|---|---|---|---|---|---|---|
| Pileridge-2 | Yes | Waste | Pit-2 and Pit-3 | Rock | 6 | 20 | 65 | -- | -- | -- | NM0130_008 NM0130_009 NM0130_010 | -- |

Photo 8-Looking west at Pileridge-2.

Photo 9-Looking south at Pileridge-2.

Photo 10-Looking north at Pileridge-2.

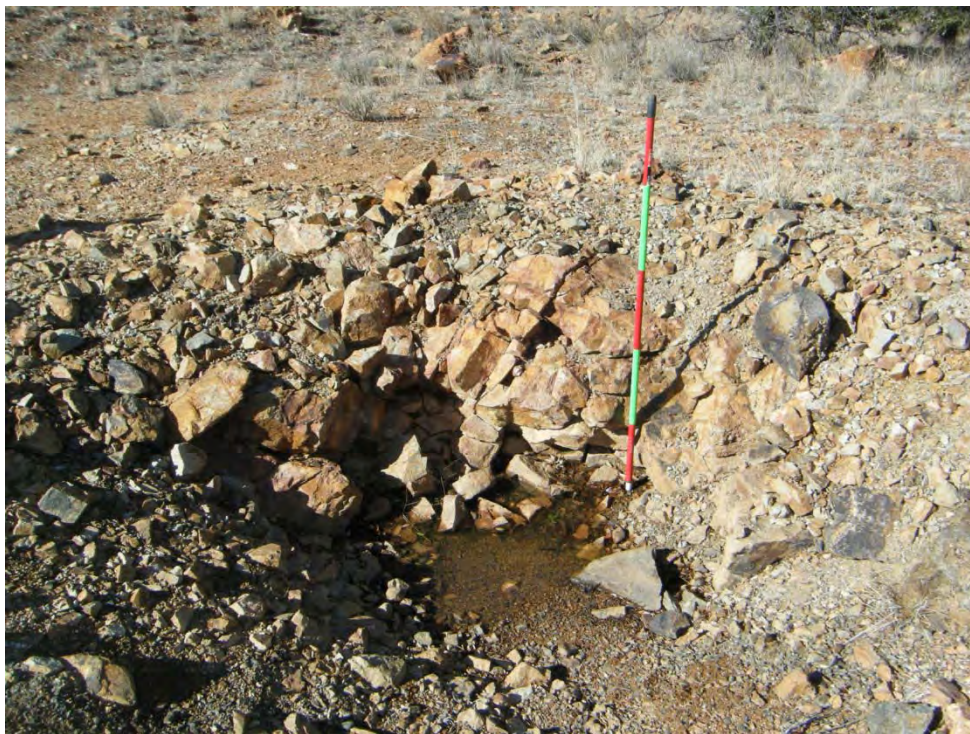
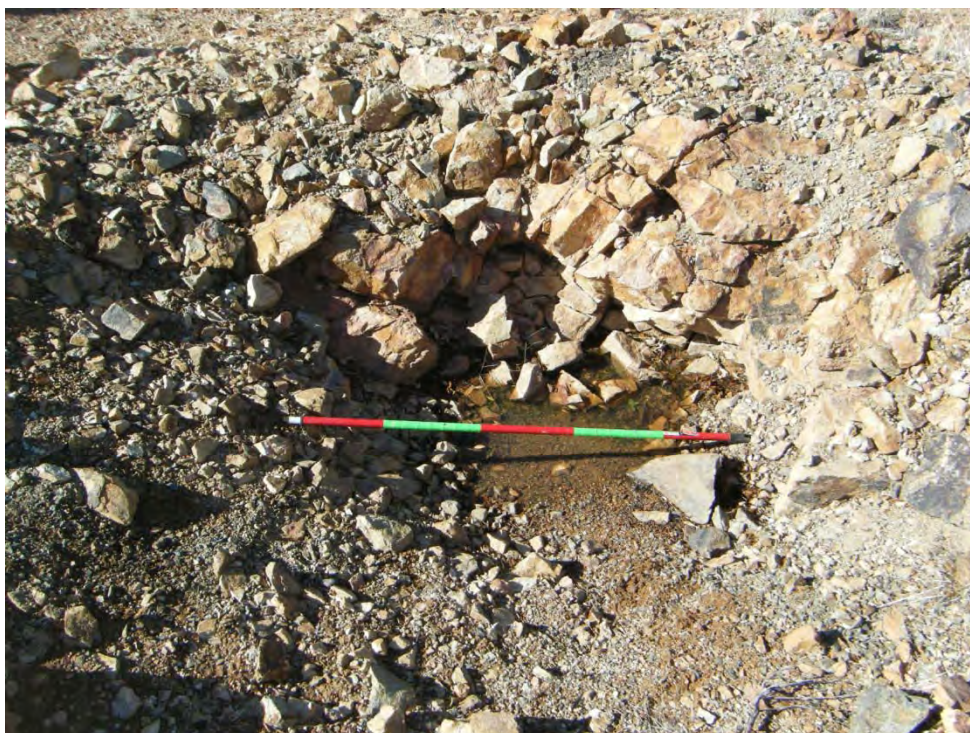
| Feature Name | On Site? | Feature Type | Associated Feature | Material | Height or Depth (ft) | Width or Diameter (ft) | Length (ft) | Open | Collapsed | Closure Type | Associated Photo | Notes |
|---|---|---|---|---|---|---|---|---|---|---|---|---|
| Pit-3 | Yes | Exploration | -- | -- | 3 | 6 | 8 | Yes | No | -- | NM0130_011 NM0130_012 NM0130_013 | -- |

Photo 11-Looking south at Pit-3.

Photo 12-Looking south at Pit-3.

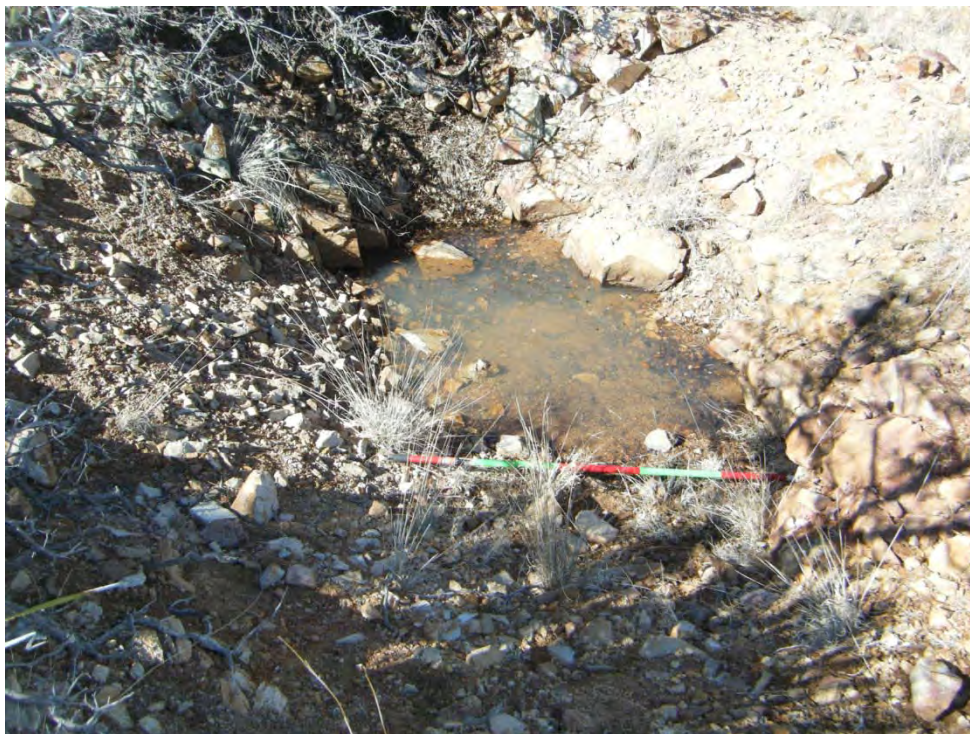
| Feature Name | On Site? | Feature Type | Associated Feature | Material | Height or Depth (ft) | Width or Diameter (ft) | Length (ft) | Open | Collapsed | Closure Type | Associated Photo | Notes |
|---|---|---|---|---|---|---|---|---|---|---|---|---|
| Pit-4 | Yes | Exploration | -- | -- | 4 | 10 | 15 | Yes | No | -- | NM0130_025 | -- |

Photo 25-Looking south at Pit-4.

4' deep, 15' long, 10' wide; water in the bottom

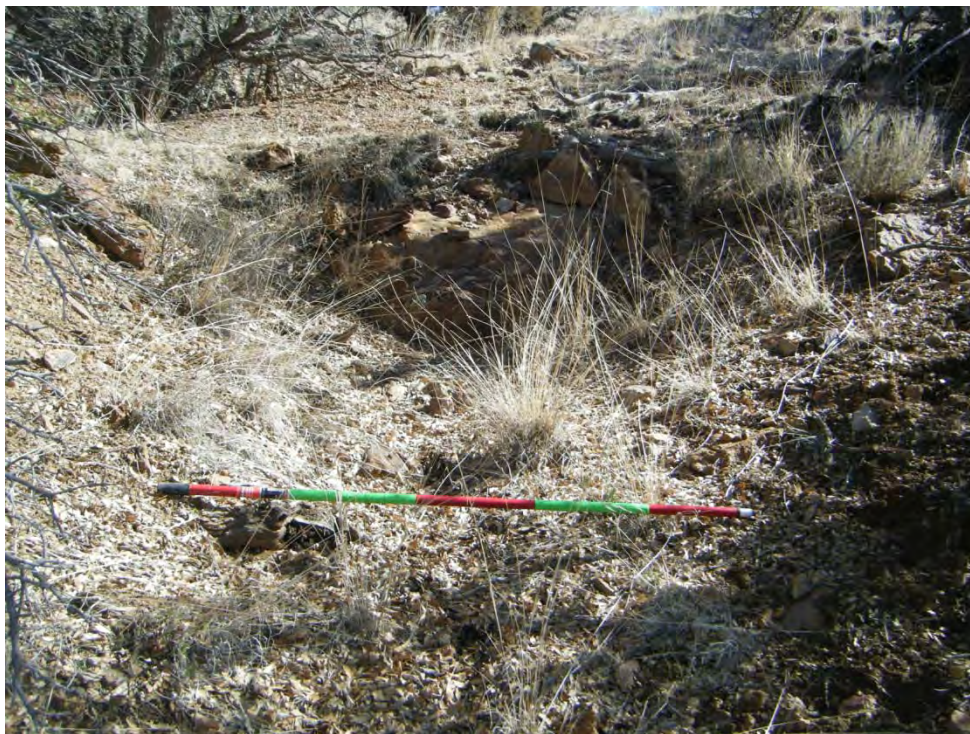
| Feature Name | On Site? | Feature Type | Associated Feature | Material | Height or Depth (ft) | Width or Diameter (ft) | Length (ft) | Open | Collapsed | Closure Type | Associated Photo | Notes |
|---|---|---|---|---|---|---|---|---|---|---|---|---|
| CutLn-1 | Yes | -- | -- | -- | 4 | 12 | 18 | Yes | No | -- | NM0130_027 | -- |

Photo 27-Looking north at Cutln-1.

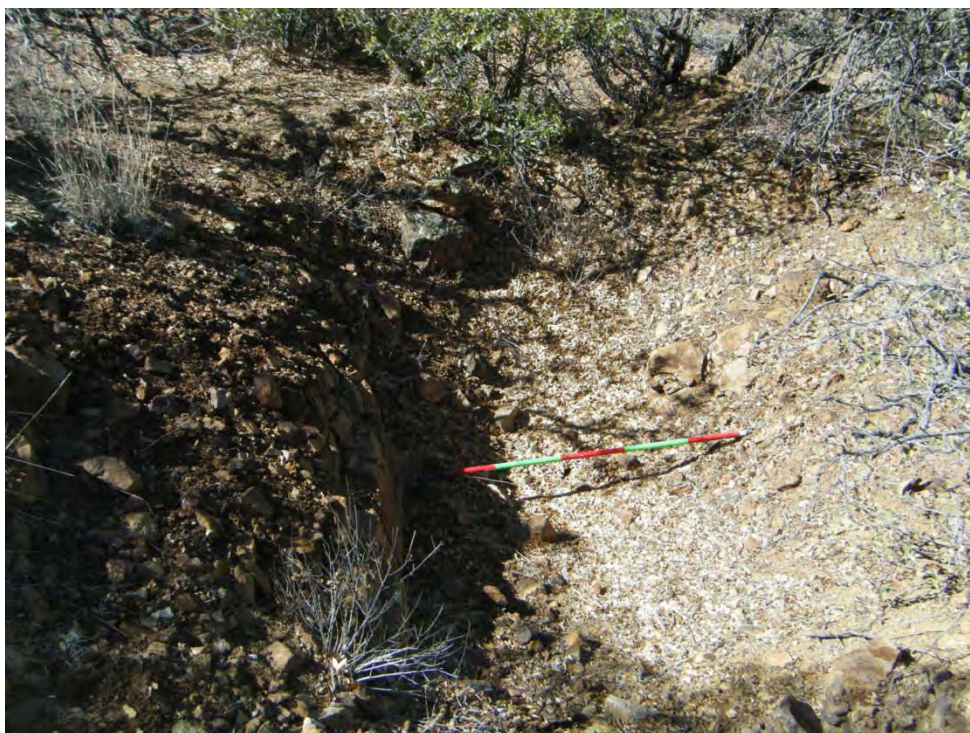
| Feature Name | On Site? | Feature Type | Associated Feature | Material | Height or Depth (ft) | Width or Diameter (ft) | Length (ft) | Open | Collapsed | Closure Type | Associated Photo | Notes |
|---|---|---|---|---|---|---|---|---|---|---|---|---|
| Pit-6 | Yes | Exploration | -- | -- | 7 | 8 | 15 | Yes | No | -- | NM0130_028 NM0130_029 | -- |

Photo 28-Looking south at Pit-6.

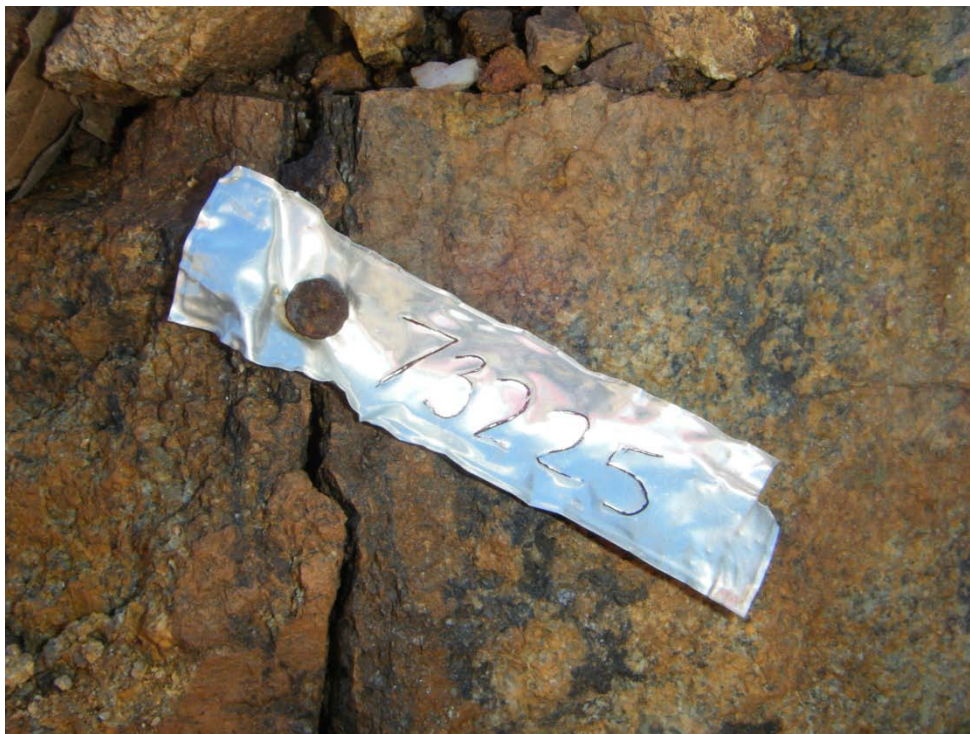
Photo 29-Metal tag in Pit-6, "73225" (PhotoPt-3).

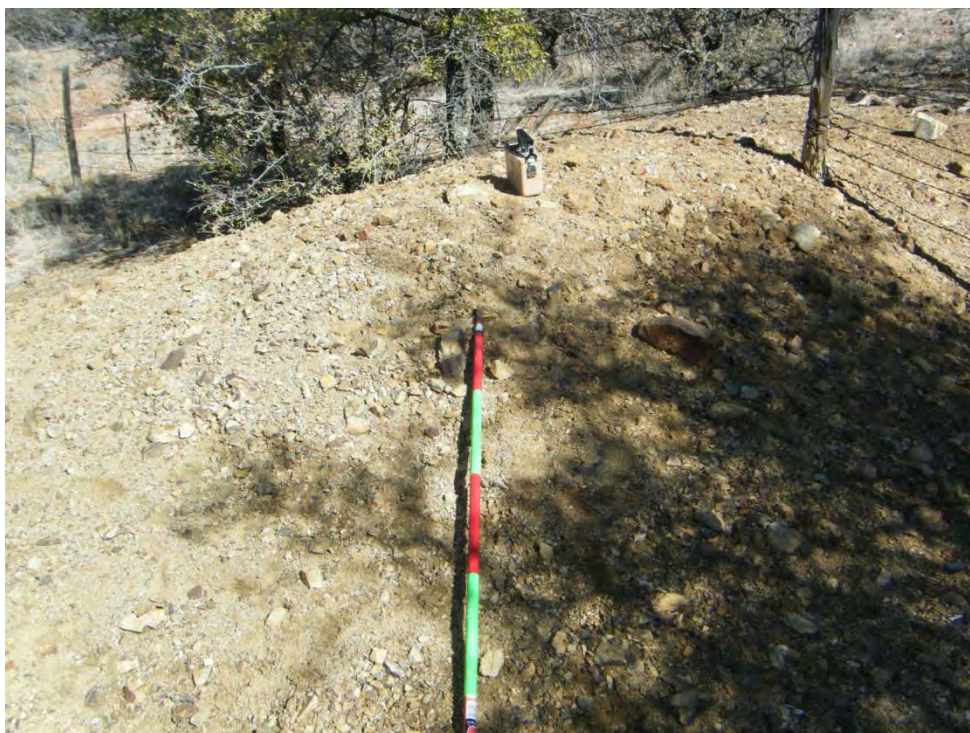
| Feature Name | On Site? | Feature Type | Associated Feature | Material | Height or Depth (ft) | Width or Diameter (ft) | Length (ft) | Open | Collapsed | Closure Type | Associated Photo | Notes |
|---|---|---|---|---|---|---|---|---|---|---|---|---|
| PilePly-1 | Yes | Waste | Pit-6 | Rock | 5 | 25 | 50 | -- | -- | -- | NM0130_030 | -- |

Photo 30- Looking northwest at PilePly-1.

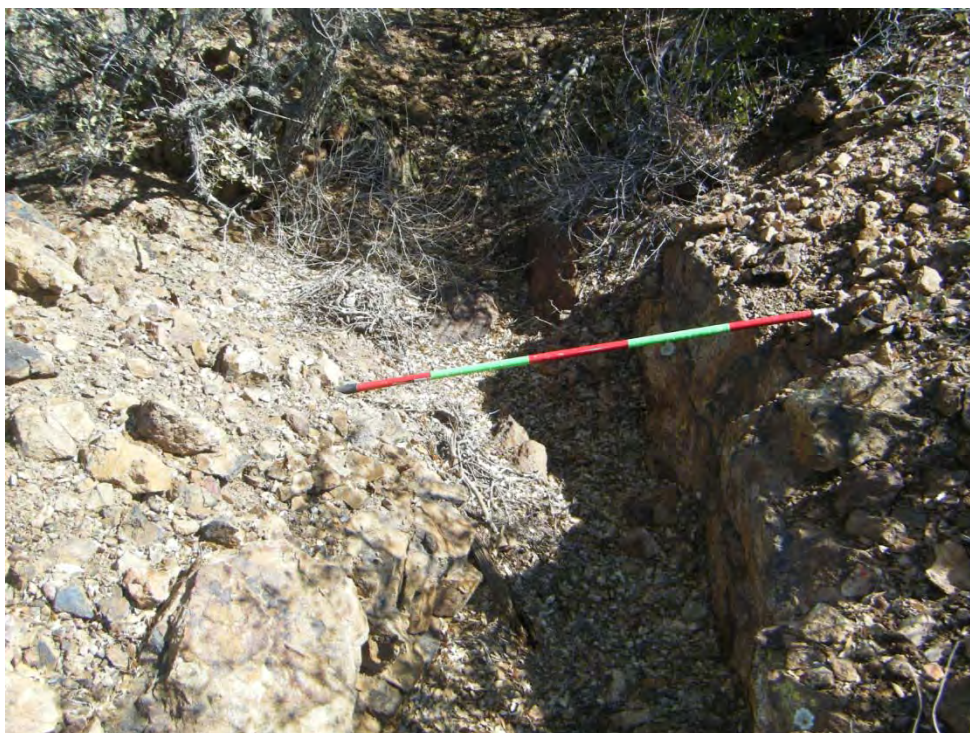
| Feature Name | On Site? | Feature Type | Associated Feature | Material | Height or Depth (ft) | Width or Diameter (ft) | Length (ft) | Open | Collapsed | Closure Type | Associated Photo | Notes |
|---|---|---|---|---|---|---|---|---|---|---|---|---|
| CutLn-2 | Yes | -- | -- | -- | 3 | 7 | 6 | Yes | No | -- | NM0130_032 | -- |

Photo 32-Looking north at CutLn-2.

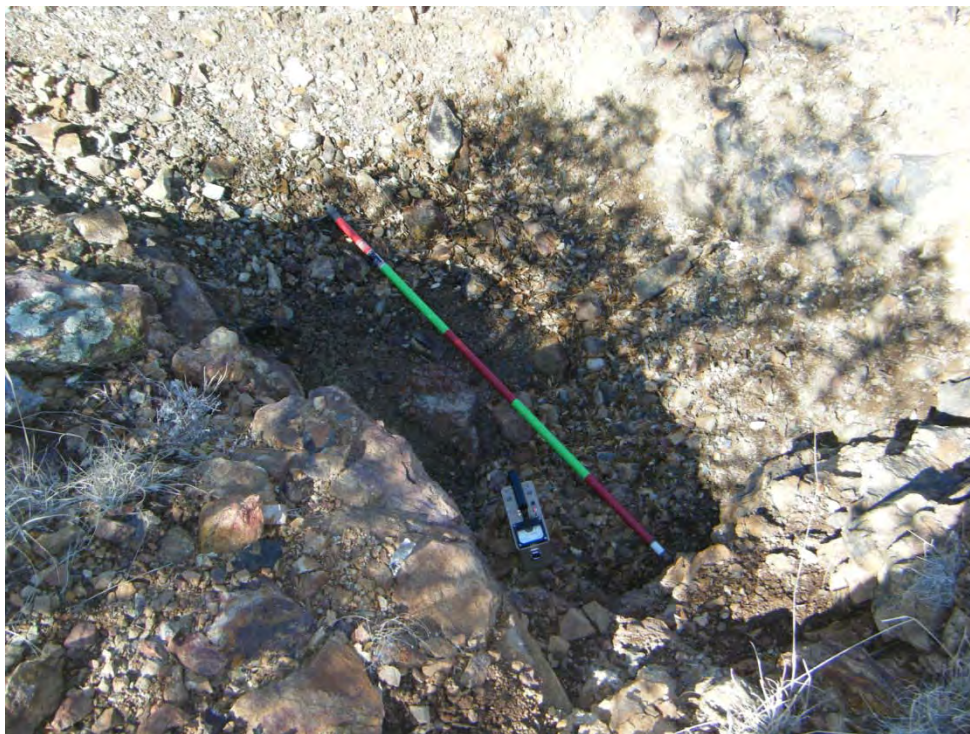
| Feature Name | On Site? | Feature Type | Associated Feature | Material | Height or Depth (ft) | Width or Diameter (ft) | Length (ft) | Open | Collapsed | Closure Type | Associated Photo | Notes |
|---|---|---|---|---|---|---|---|---|---|---|---|---|
| Pit-7 | Yes | Exploration | -- | -- | 3 | 6 | 10 | Yes | No | -- | NM0130_033 NM0130_034 NM0130_035 NM0130_041 | -- |

Photo 33-Looking south at Pit-7.

Pit 7 may have been filled in

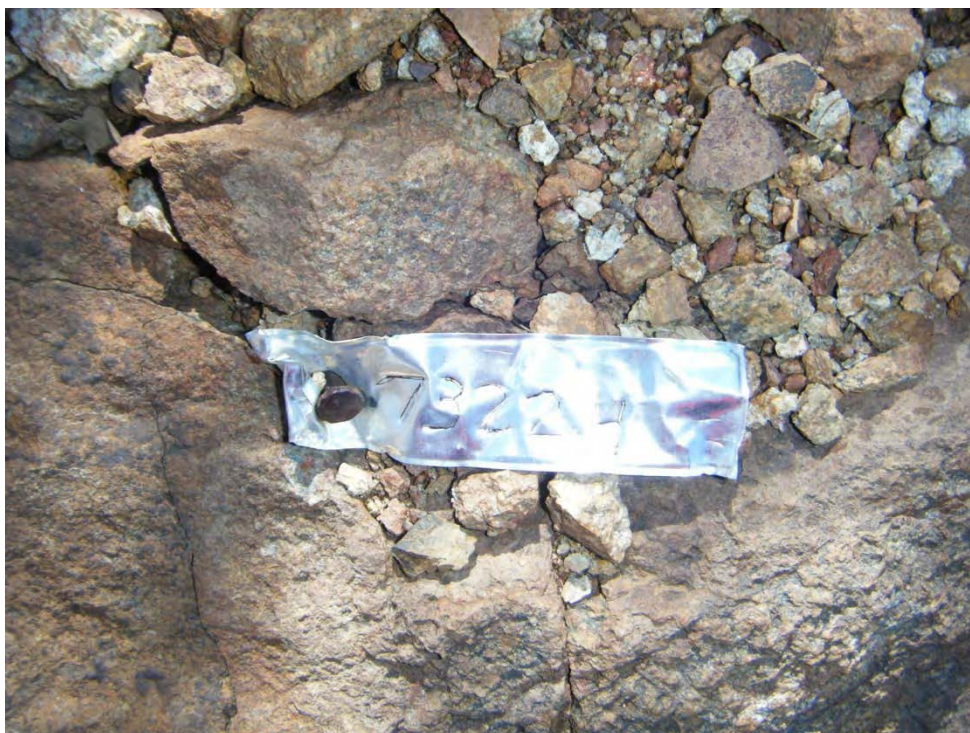
Photo 34-Metal tag in Pit-7, "73224" (PhotoPt-4).

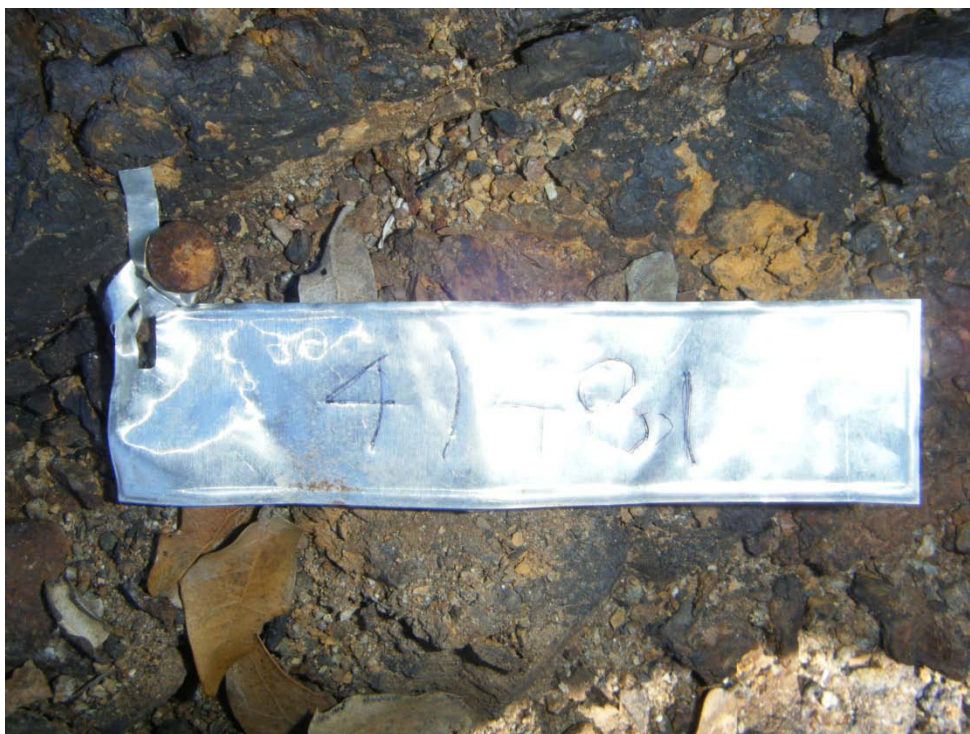
Photo 35-Metal tag in Pit-7, "41481" (PhotoPt-5).

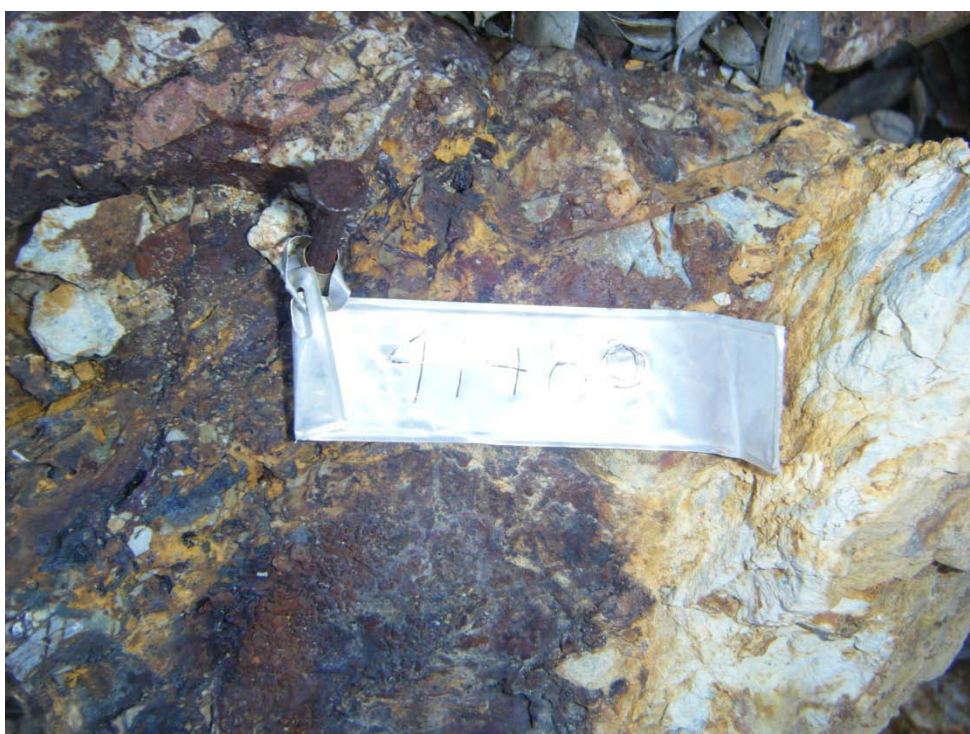
| Reading ID | Asssociated Feature | Reading at 0ft Above Ground (μR/hr) | Reading at 4ft Above Ground (μR/hr) | Associated Photo |
|---|---|---|---|---|
| Rad-13 | PhotoPt-6 | 40 | 32 | NM0130_036 |

Photo 36-Metal tag attached to loose rock on western edge of DistPly-2, "41480" (PhotoPt-6).

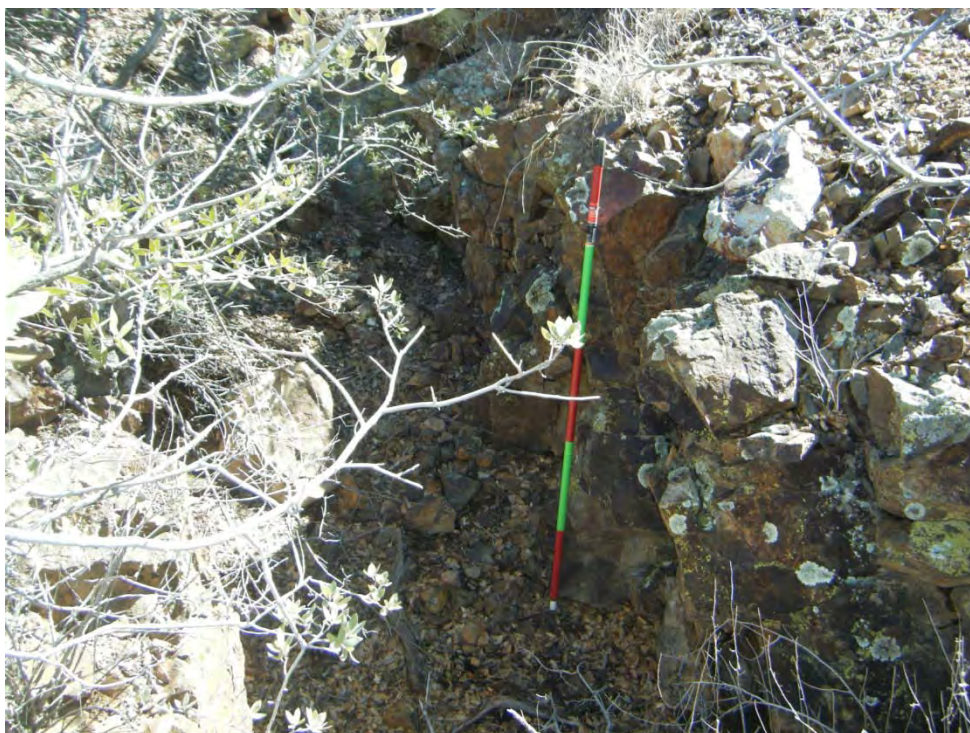
The highest gamma radiation readings at the AUM Site were found in the vicinity of DistPly-2 at the base of the hill. Exploration Pit-8 had gamma radiation readings of $150 \mu\text{R/hr}$ at the ground surface and $40 \mu\text{R/hr}$ at 4 feet above the ground surface (Rad-14). Another gamma radiation reading (Rad-16) taken on PilePly-2 was measured at $110 \mu\text{R/hr}$ at the ground surface and $70 \mu\text{R/hr}$ at 4 feet above the ground surface. The highest reading at the top of the hill (DistPly-1) were measured in Pit-1 and measured $96 \mu\text{R/hr}$ at the ground surface and $37 \mu\text{R/hr}$ at 4 feet above the ground surface. Please see Table 2 for details.

| Feature Name | On Site? | Feature Type | Associated Feature | Material | Height or Depth (ft) | Width or Diameter (ft) | Length (ft) | Open | Collapsed | Closure Type | Associated Photo | Notes |
|---|---|---|---|---|---|---|---|---|---|---|---|---|
| Pit-8 | Yes | Exploration | -- | -- | 5 | 6 | 15 | Yes | No | -- | NM0130_037 NM0130_038 | -- |

Photo 37-Looking north at Pit-8.

Photo 38-Looking northeast at Pit-8.

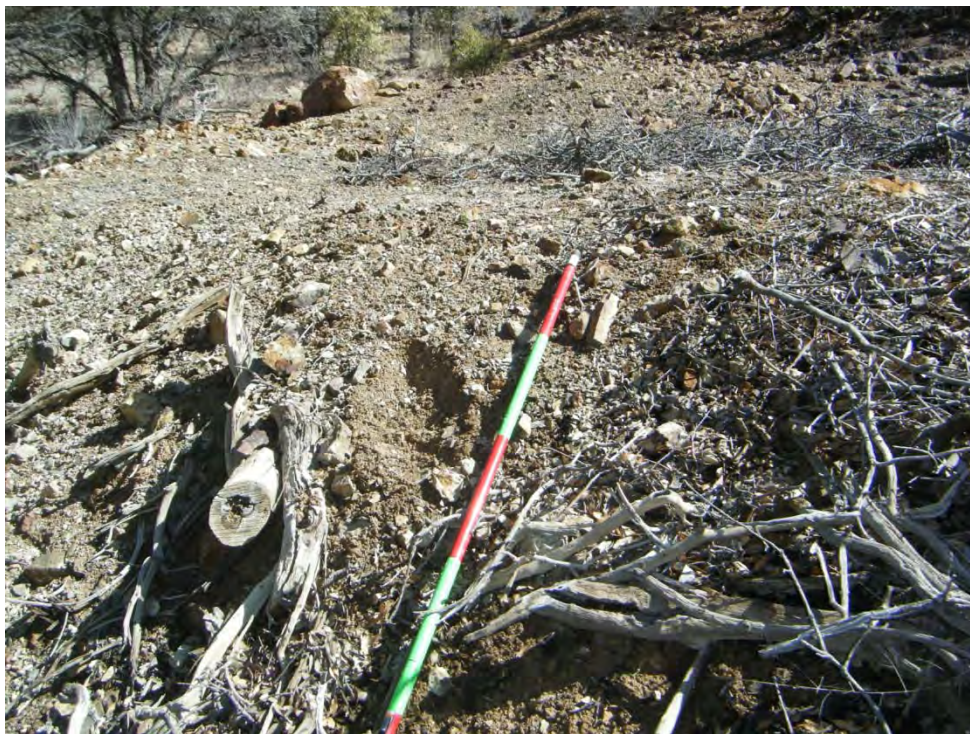
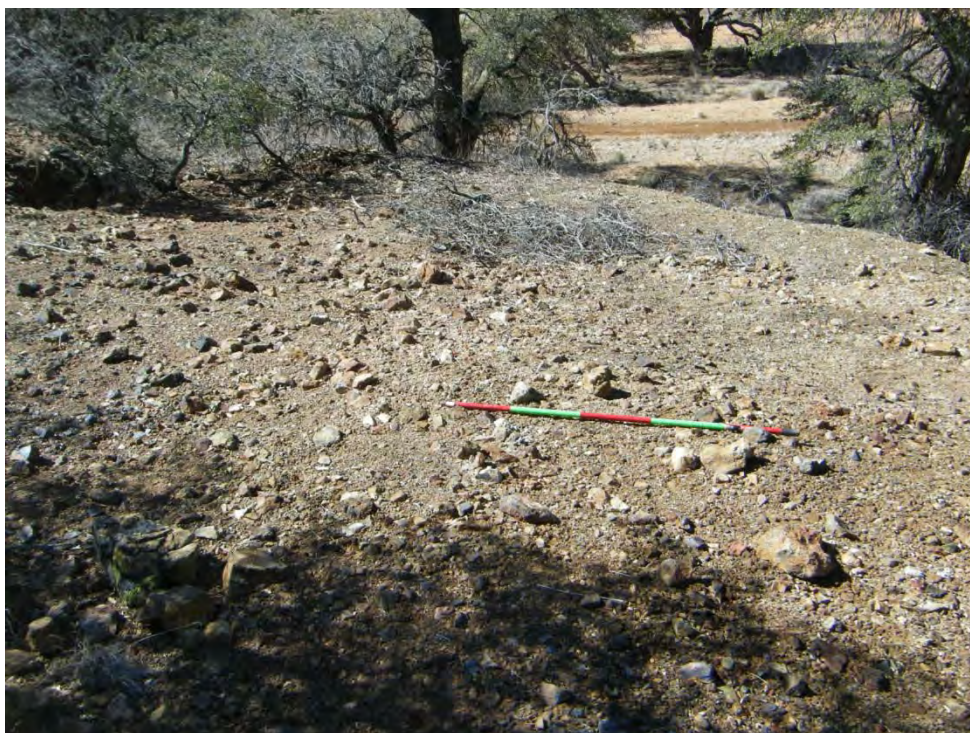
| Feature Name | On Site? | Feature Type | Associated Feature | Material | Height or Depth (ft) | Width or Diameter (ft) | Length (ft) | Open | Collapsed | Closure Type | Associated Photo | Notes |
|---|---|---|---|---|---|---|---|---|---|---|---|---|
| PilePly-2 | Yes | Waste | CutLn-2 and Pit-7 | Rock | 5 | 20 | 25 | -- | -- | -- | NM0130_039 NM0130-040 | -- |

| Reading ID | Asssociated Feature | Reading at 0ft Above Ground (μR/hr) | Reading at 4ft Above Ground (μR/hr) | Associated Photo |
|---|---|---|---|---|
| Rad-16 | PilePly-2 | 110 | 70 | -- |

Photo 39-Looking north at PilePly-2.

Photo 40-Looking south at PilePly-2.

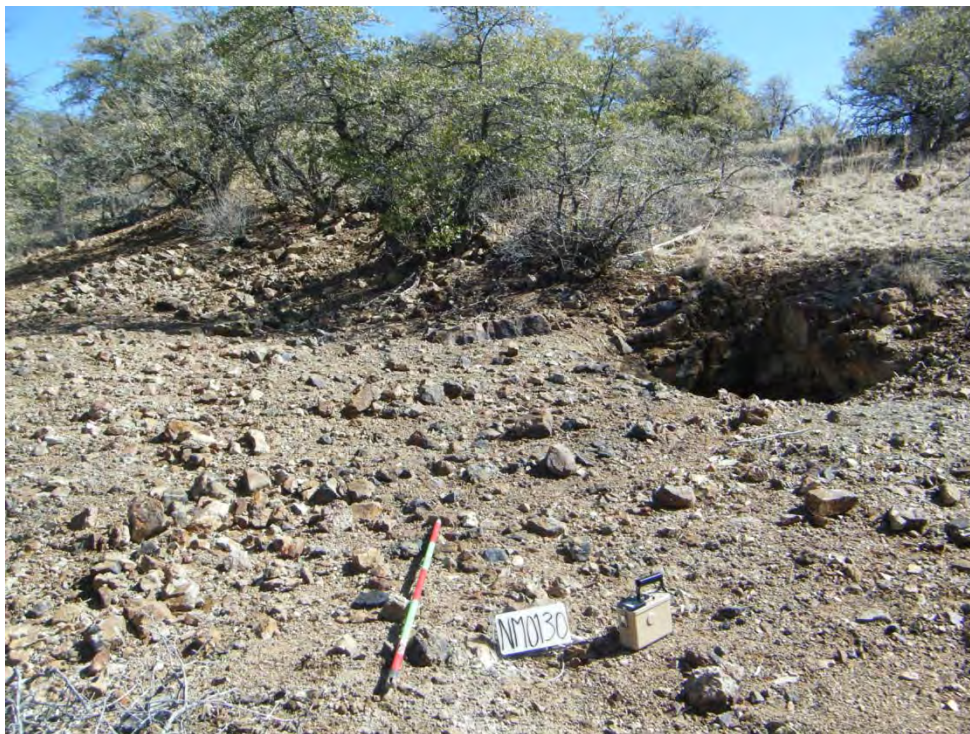
Photo 41-Looking northeast at site name on DistPly-2, Pit-7 is on the right.

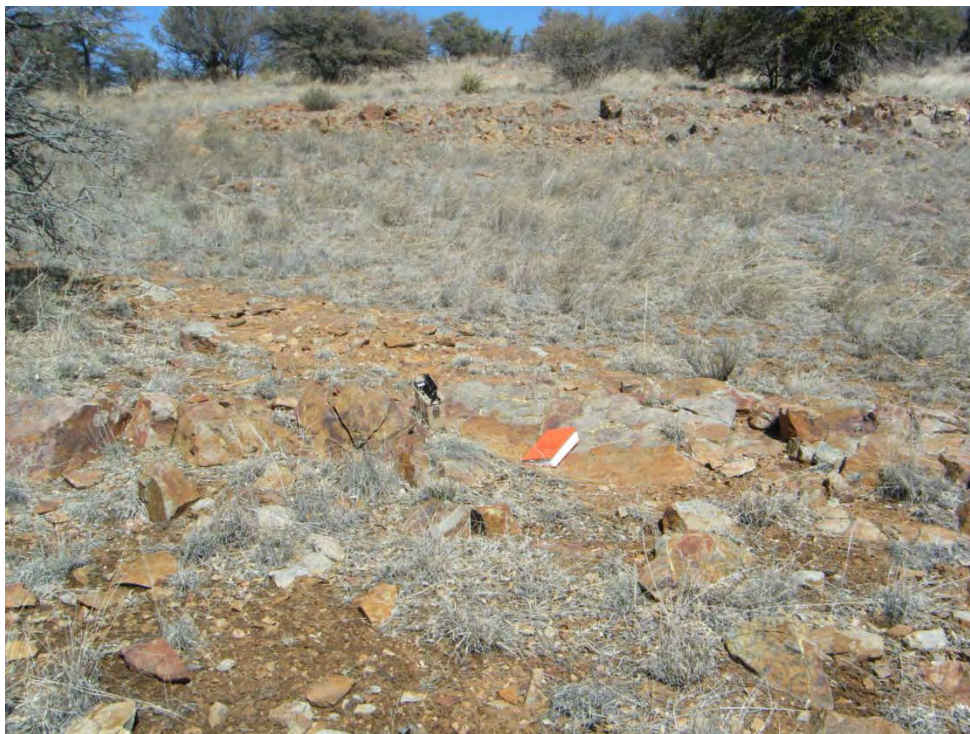
| Reading ID | Asssociated Feature | Reading at 0ft Above Ground (μR/hr) | Reading at 4ft Above Ground (μR/hr) | Associated Photo |
|---|---|---|---|---|
| Rad-17 | RadBack-2 | 30 | 25 | NM0130_046 |

Photo 46-Looking north at the given AUM location, no evidence of mine features.

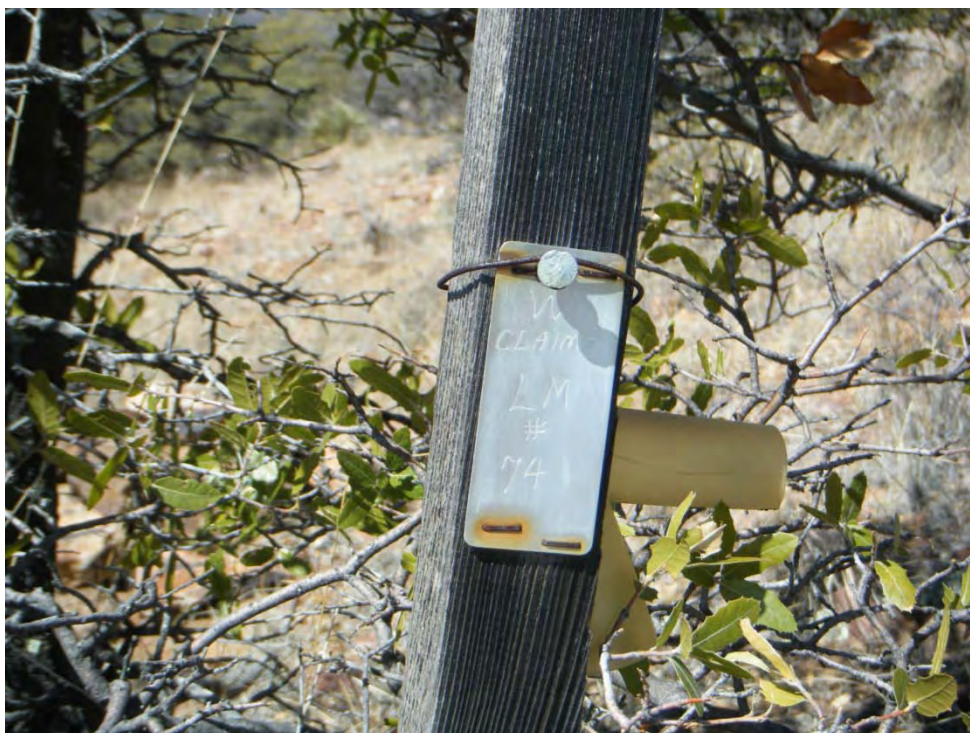
| Feature Name | On Site? | Feature Type | Associated Feature | Material | Height or Depth (ft) | Width or Diameter (ft) | Length (ft) | Open | Collapsed | Closure Type | Associated Photo | Notes |
|---|---|---|---|---|---|---|---|---|---|---|---|---|
| Claim-1 | No | Sign | -- | -- | -- | -- | -- | -- | -- | -- | NM0130_047 | "W Claims, LM #74" |

Photo 47-Looking west at mine claim, east of AUM Site location, "W Claim LM #74."
